### Case Study

# Old Courthouse, Fremantle, WA

**StormBrixx<sup>®</sup> SD** – 156m<sup>3</sup> geocellular stormwater tank.

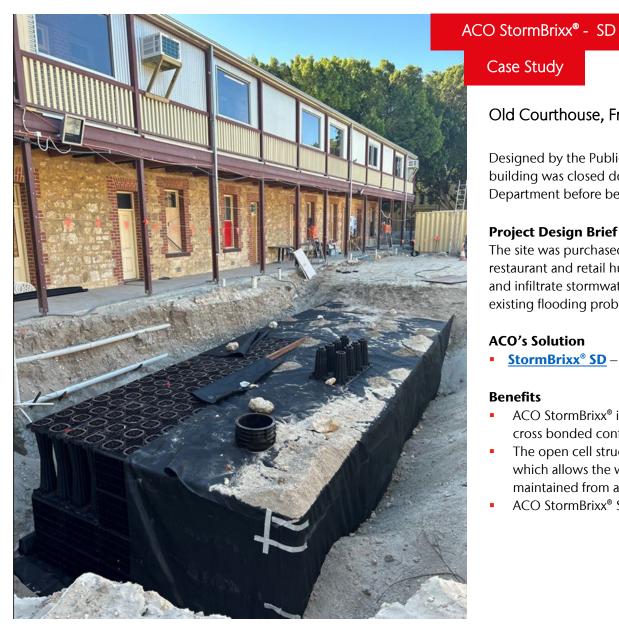
- ACO StormBrixx<sup>®</sup> is strong and quick to assemble. It is installed in a brick bonded and • cross bonded configuration for optimal stability.
- The open cell structure permits completely free access for CCTV and jetting equipment which allows the whole system, including all the extremities, to be inspected and maintained from a few access points.
- ACO StormBrixx<sup>®</sup> SD offers optimum storage capacity with 97% void ratio of total volume.
